Navajo Abandoned Uranium Mine

Site Screen Report

Mesa IV, West Mine AUM Site

March 2010

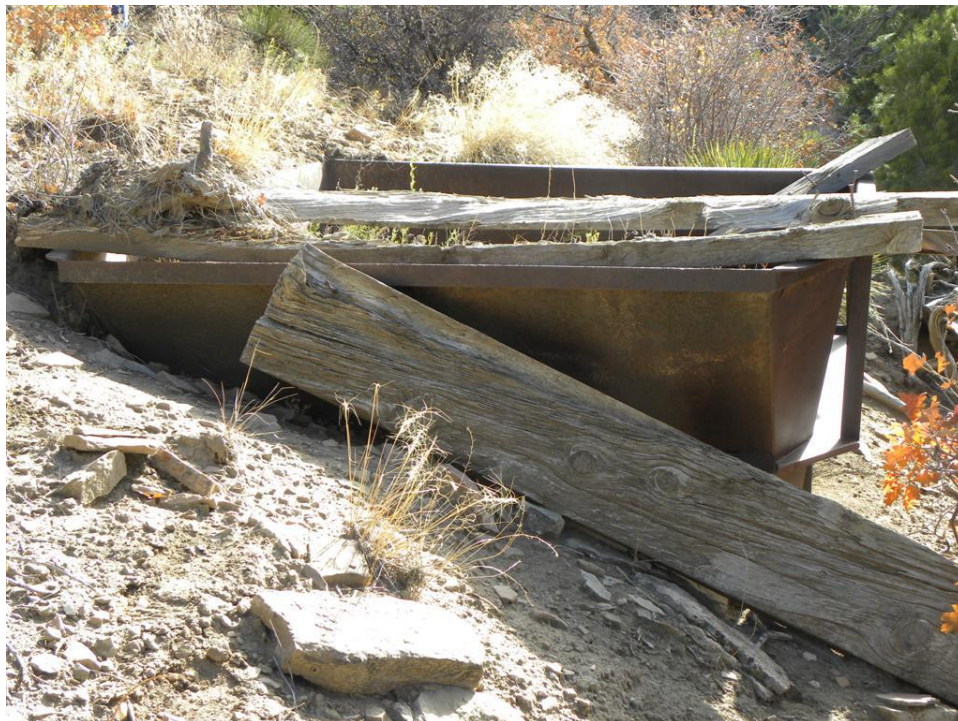
Photo 1. Metal container

A total of 1,024 gamma radiation measurements were collected from the mine site, ranging from 8,789 cpm to 16,182 cpm. Measurements in the vicinity of the metal container were found at levels of approximately 13,000 cpm. The measurements are represented in Figures 1 and 2.

A large metal container was found at the site
